WOOD DESTROYING PESTS AND ORGANISMS INSPECTION REPORT

Building Address: 237 Socrates Pl., El Dorado Hills, CA 95762		Date of Inspection 10/07/2015	Number of Pages 10

Report # W8380
				Lic. Registration # PR 5806
Escrow #				
Ordered by:	Property Owner and/or Party of Interest:	Report Sent to:		
COMPLETE REPORT <input checked="" type="checkbox"/> LIMITED REPORT <input type="checkbox"/> SUPPLEMENTAL REPORT <input type="checkbox"/> REINSPECTION REPORT <input type="checkbox"/>				
General Description: Two story stucco single family residence		Inspection Tag Posted: Garage	Other Tags Posted: Na	
An inspection has been made of the structure(s) shown on the diagram in accordance with the Structural Pest Control Act. Detached porches, detached steps, detached decks and any other structures not on the diagram were not inspected.

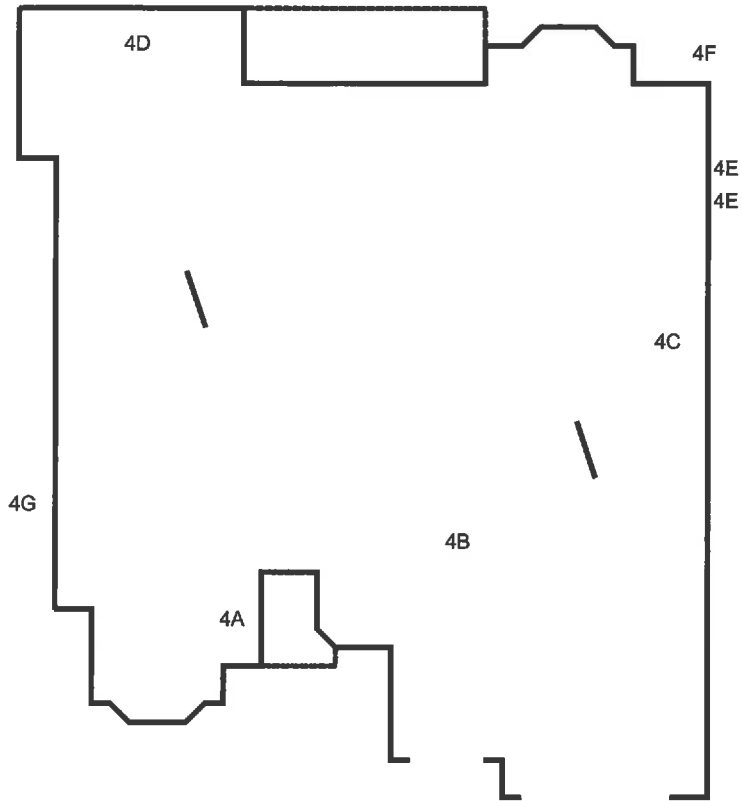
This Diagram is not to scale

- 4E (Section II)
FINDINGS: Faulty grade at the right rear corner where the foliage grows adjacent to the foundation and side of the residence.
RECOMMENDATION: Lower leaves and trim back the foliage to expose the foundation.

- 4F (Section II)
FINDINGS: Faulty grade as indicated on the diagram.
RECOMMENDATION: Regrade the bark away to expose 3" of visible foundation.
- 4G (Section II)
FINDINGS: Stucco cracks noted under the window trim.
RECOMMENDATION: Seal the stucco cracks stemming from the window to prevent moisture from intruding into the framing.
