WOOD DESTROYING PESTS AND ORGANISMS INSPECTION REPORT

| Building Address: 8217 Prime Wy., Citrus Heights, CA 95610 | | Date of Inspection 10/06/2015 | Number of Pages 10 | |
| General Description: Single story wood siding single family residence | | Inspection Tag Posted: Garage | | |

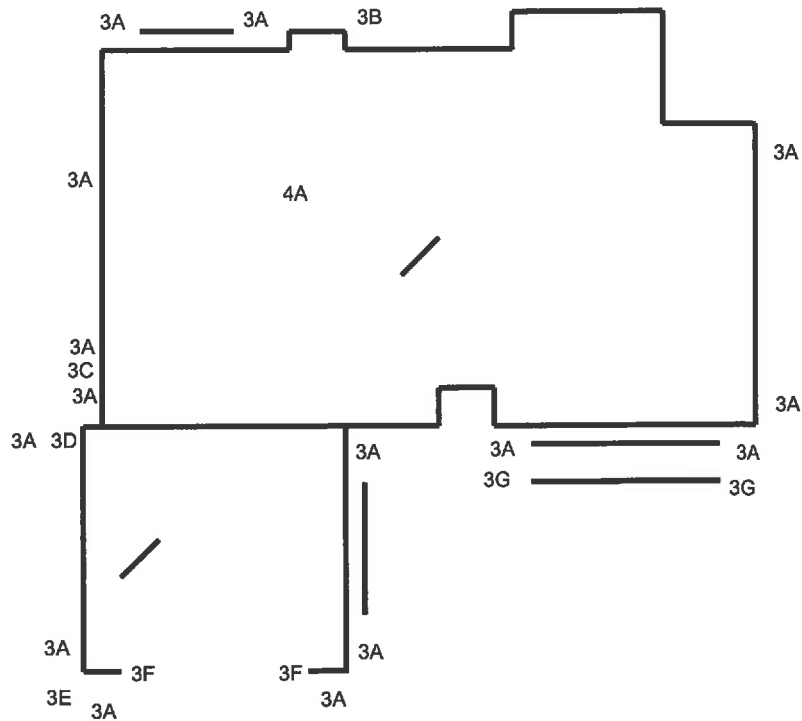
This Diagram is not to scale

| An inspection has been made of the structure(s) shown on the diagram in accordance with the Structural Pest Control Act. Detached porches, detached steps, detached decks and any other structures not on the diagram were not inspected. | | | | |
