WOOD DESTROYING PESTS AND ORGANISMS INSPECTION REPORT

Building Address: 237 Socrates Pl., El Dorado Hills, CA 95762		Date of Inspection 10/07/2015	Number of Pages 10

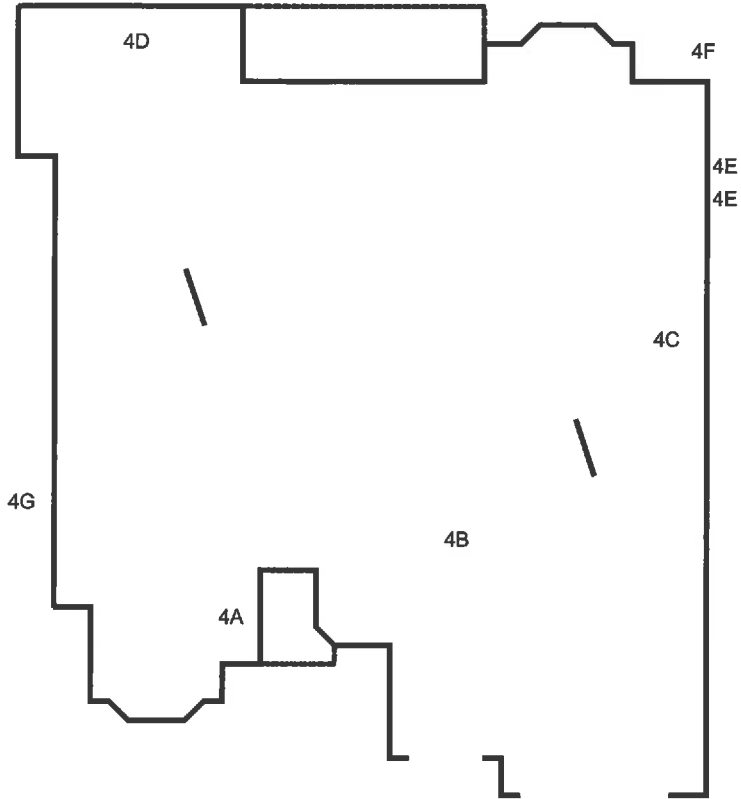
This Diagram is not to scale

- 4E (Section II)
FINDINGS: Faulty grade at the right rear corner where the foliage grows adjacent to the foundation and side of the residence.
RECOMMENDATION: Lower leaves and trim back the foliage to expose the foundation.

- 4F (Section II)
FINDINGS: Faulty grade as indicated on the diagram.
RECOMMENDATION: Regrade the bark away to expose 3" of visible foundation.
- 4G (Section II)
FINDINGS: Stucco cracks noted under the window trim.
RECOMMENDATION: Seal the stucco cracks stemming from the window to prevent moisture from intruding into the framing.
